**Reconnaissance Built Environment
Survey of Walla Walla's Germantown –
Portions of Chase's Addition, Henderson's
Addition, Freise Addition and an Unplatted
Area, Walla Walla, Washington**

AHA! Project 2015-006

August 14, 2015

CULTURAL RESOURCES REPORT COVER SHEET

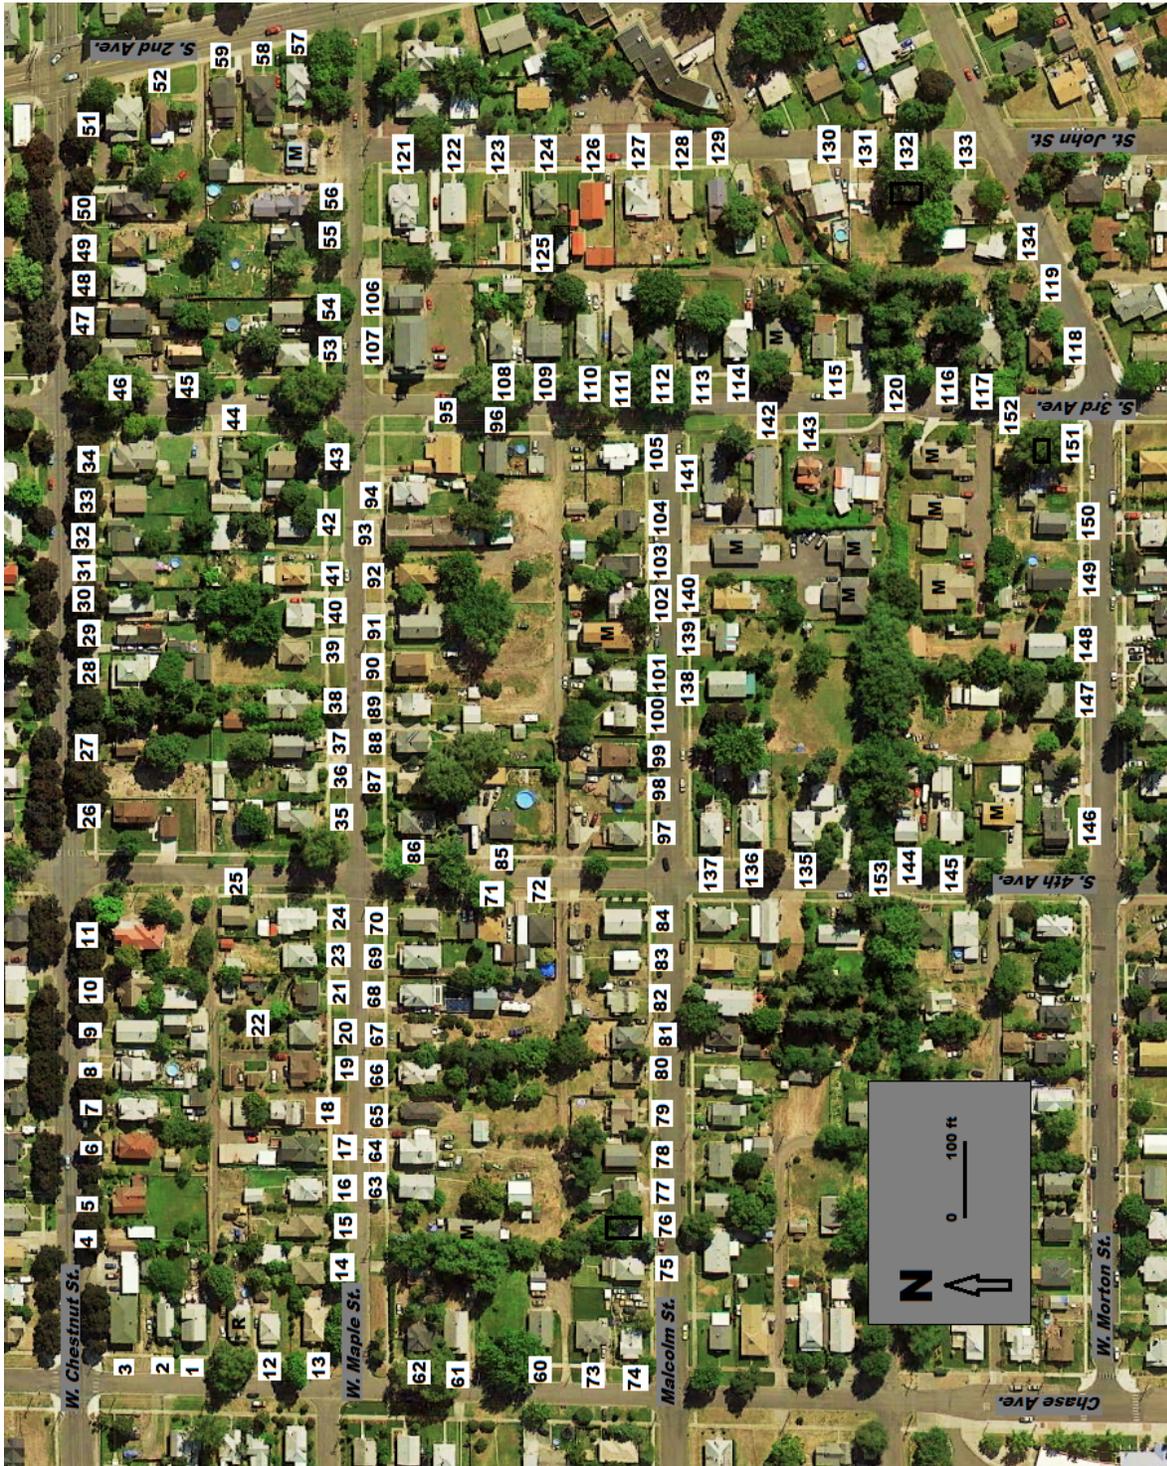
Figure 2. Survey Area, showing built environment resources (numbered), modern buildings (M), and removed buildings (R). Adapted from Google Earth aerial photograph, 2013.

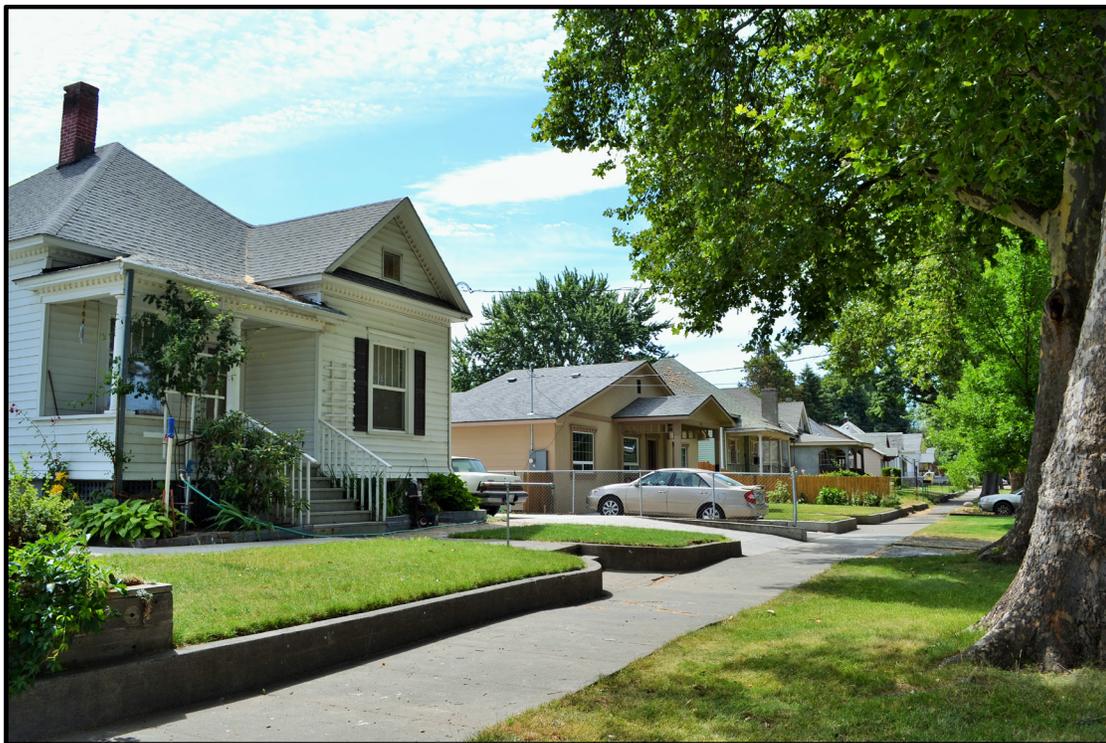
Figure 3. Overview of the Survey Area: S.3rd Avenue just south of W. Maple Street; the building at the left is Project Number 108. View to the southeast.

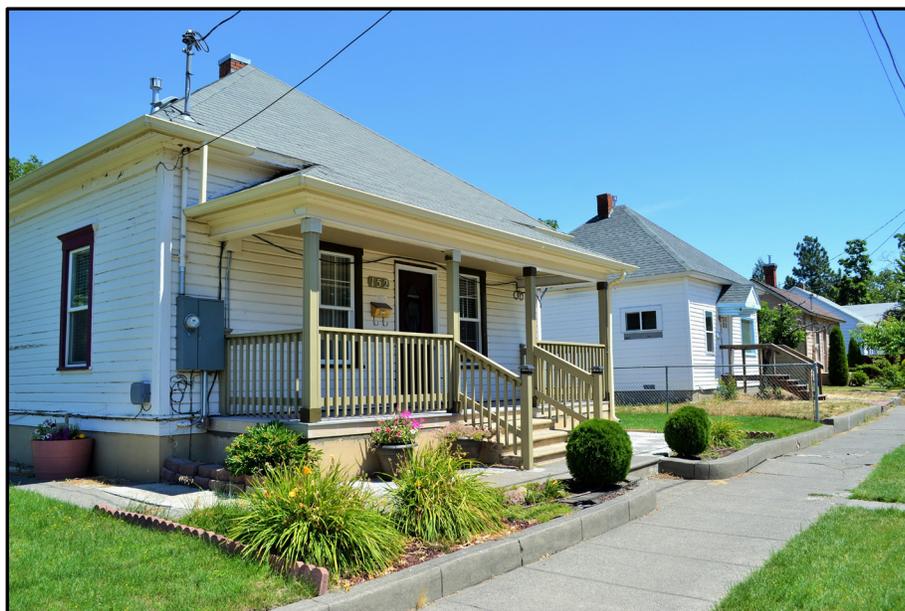
Most residences in the Survey Area are small entry-level workingman’s cottages with pyramidal, hipped, or gabled roofs (Figure 6). Despite variations in architectural style, large numbers of these small houses employ identical architectural elements and construction techniques—including classical wooden Tuscan columns, wood sash double-hung windows with decorative upper sash “tails,” and poured concrete foundations parged and scored to look like stone blocks—suggesting construction by a local developer during a discrete time period. Over the years most of these cottages have been enlarged with multiple rear additions, and nearly all have been updated with modern siding, doors, and windows. Most buildings, however, retain their historical form and remain readily recognizable as historical structures. Many residences are associated with small, detached garages or other historical outbuildings, sited to the rear of the house and accessed by narrow driveways or from the alleys.

Figure 6. Overview of homes on Malcolm Street just east of S. 4th Avenue; the building at the left is Project Number 97. View to the northeast.

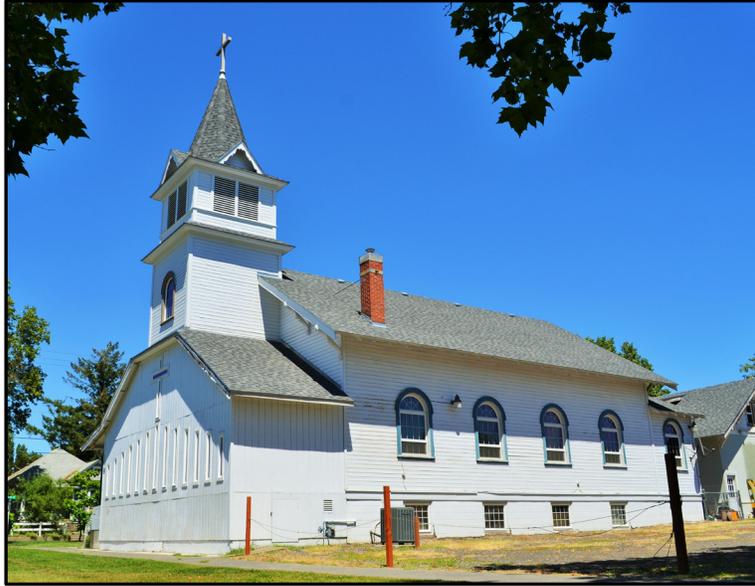
Two historical churches and four commercial buildings were identified in the Survey Area. The two churches, a long-vacant brewery/store, and a former store/dry cleaning establishment, all associated with the historical Volga German community, are situated along W. Maple Street, apparently the enclave’s major thoroughfare. The churches were built in 1904 and 1922 and each played a significant role in the German community’s cultural cohesion (Figure 7). Two more historical commercial buildings, a former plumber’s shop and a former gas station, are sited along W. Chestnut Street at the northern boundary of the project. Whether these buildings were associated with the historical German community remains unknown.

Figure 7. German Lutheran Church built in 1922 at 801 S. 3rd Avenue (Project Number 107), west and south sides.

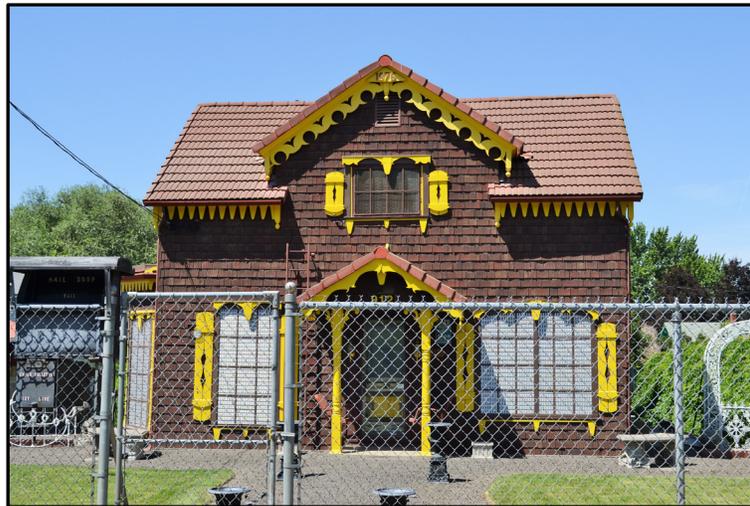
A large building identified by lifelong area resident Rondall “Ron” Brown (personal communication 2015) as the first home built in the area, the 1876 Henderson residence, is situated on S. 3rd Avenue in the southern Survey Area (Figure 8). This house, which predates the period of Volga German immigration, is believed to be the residence of the prominent Henderson family that platted Henderson’s Addition. Although this residence remains recognizable as a historical building, extensive remodeling has altered nearly all visible elements.

Figure 8. Heavily remodeled home at 912 S. 3rd Avenue (Project Number 143), the 1876 Henderson House, east elevation.

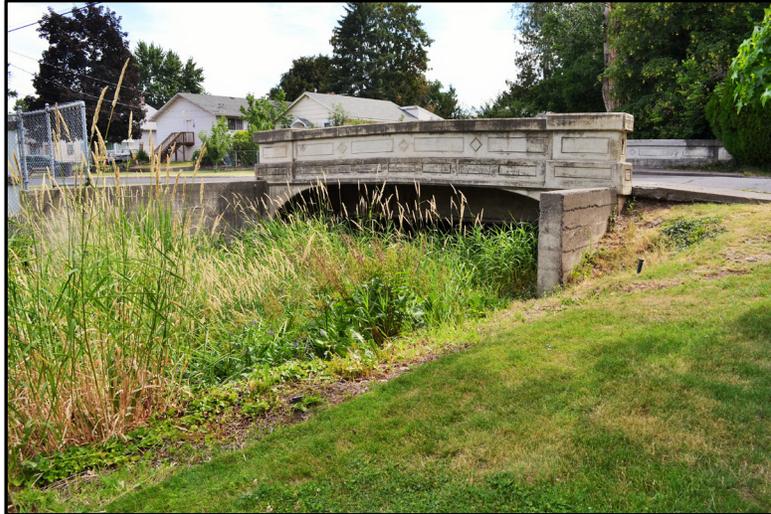
Two concrete bridges convey traffic on S. 3rd and S. 4th avenues over Garrison Creek in the southern Survey Area (Figure 9). The S. 3rd Avenue Bridge was built in 1928 (Rondall Brown, personal communication 2015), while the S. 4th Avenue Bridge was built in 1939, according to a bridge placard, as a Works Progress Administration Depression-relief project.

Figure 9. S. 3rd Avenue Bridge (Project Number 120). View to the northeast.

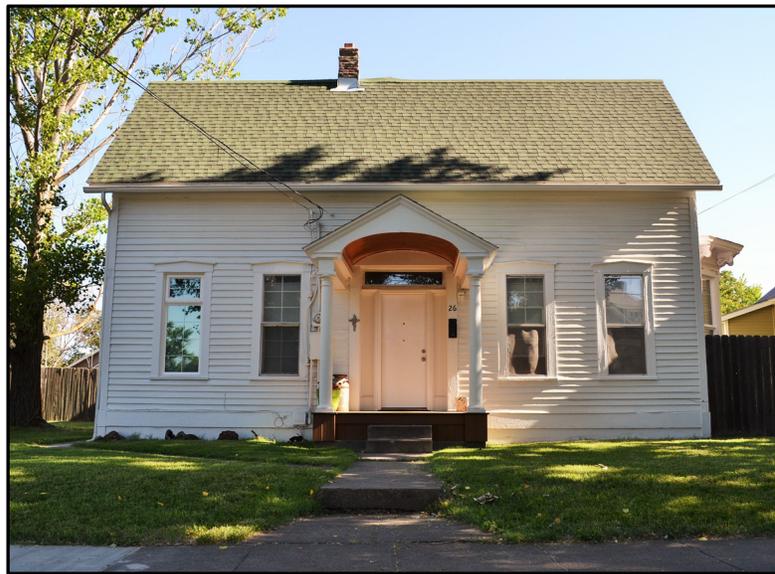
One building in the Survey Area, the house at 26 W. Maple Street (Project Number 55), is a classic vernacular example of the Greek Revival architectural tradition, based on its pedimented windows, front door transom and sidelights, symmetrical arrangement, and wide trim band at the cornice line (Figure 10). The building's classical-inspired front porch and side bay window appear to be later additions. Historical maps indicate that the building was moved to its present location in the early twentieth century.

Figure 10. Greek Revival style: House at 26 W. Maple St. (Project Number 55), south elevation.

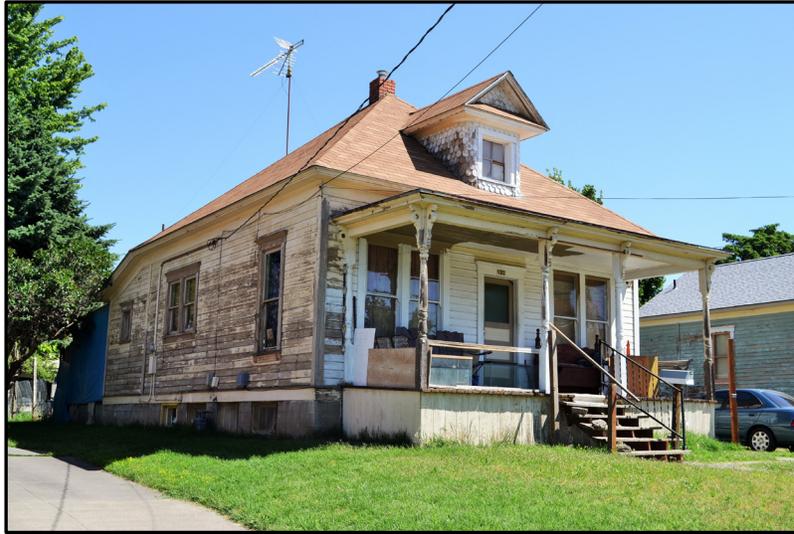
Figure 11. Queen Anne – Spindework style: House at 122 W. Maple St. (Project Number 41), west and south (front) sides.

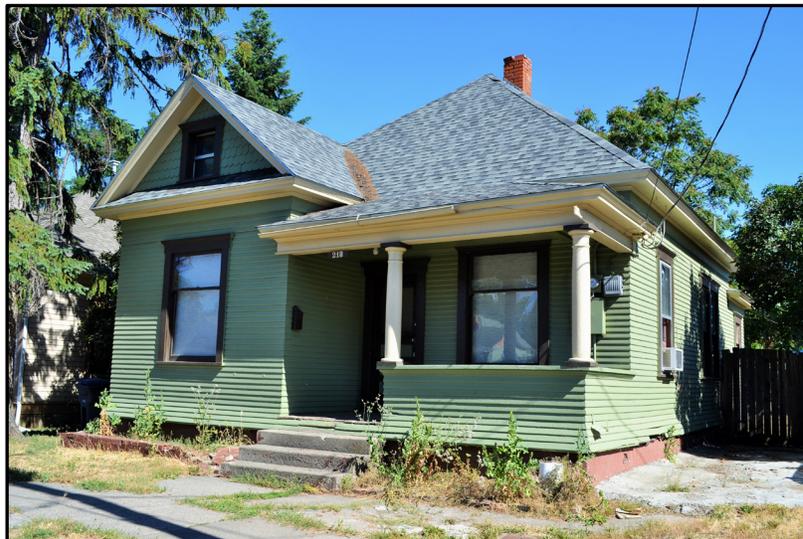
Figure 12. Queen Anne – Free Classic style: House at 218 Malcolm St. (Project Number 81), south (front) and east sides.

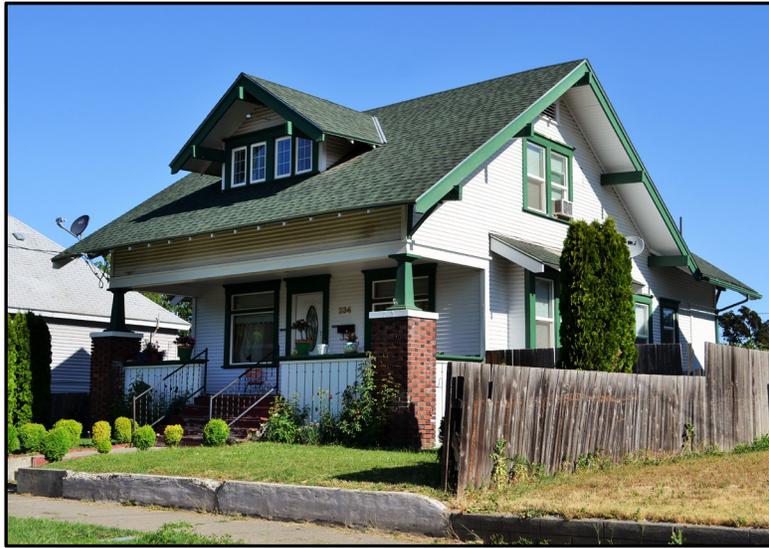
Figure 13. Craftsman Bungalow style: House at 234 W. Maple St. (Project Number 17), south (front) and east sides.

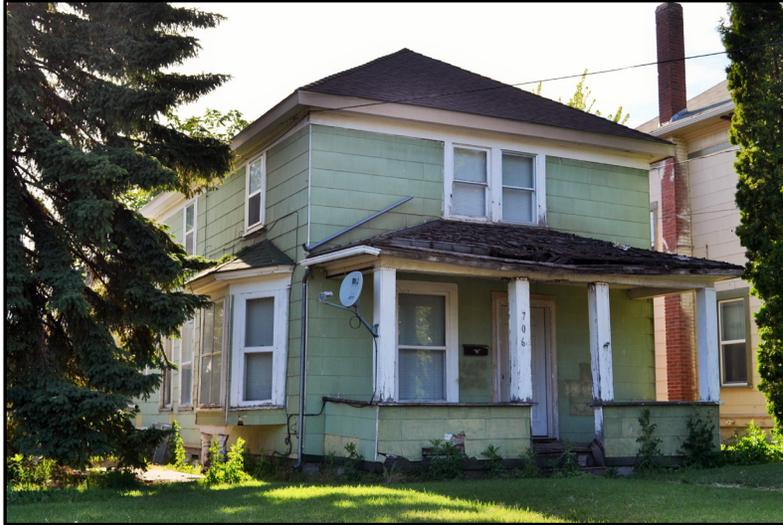
Several buildings in the Survey Area are vernacular expressions of the Colonial Revival architectural tradition (Figure 14). The style has been divided into a number of subtypes and buildings within the project represent the American Foursquare, Cape Cod, and Williamsburg Revival categories.

Figure 14. Colonia Revival – American Foursquare style: House at 706 S. 2nd Ave. (Project Number 52), south and east (front) sides.

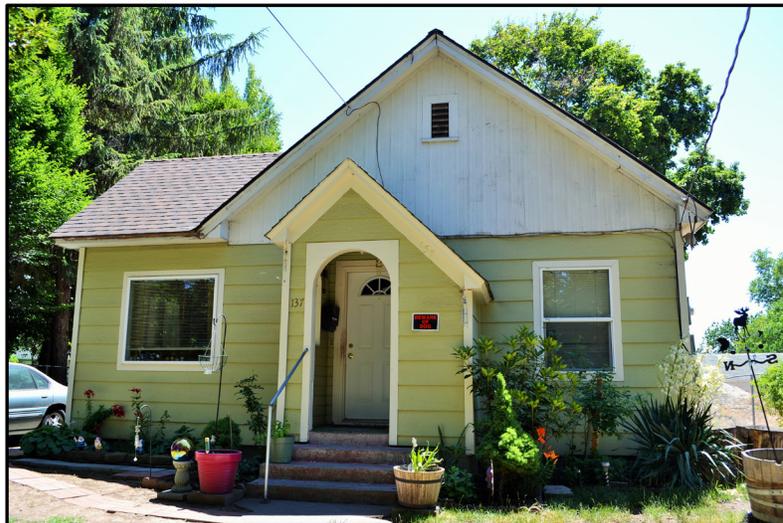
Only two Tudor buildings are present in the Survey Area (Project Numbers 27 and 34) (Figure 15), one a Tudor update to an older Queen Anne residence.

Figure 15. Tudor style: House at 137 W. Chestnut St. (Project Number 27), north side.

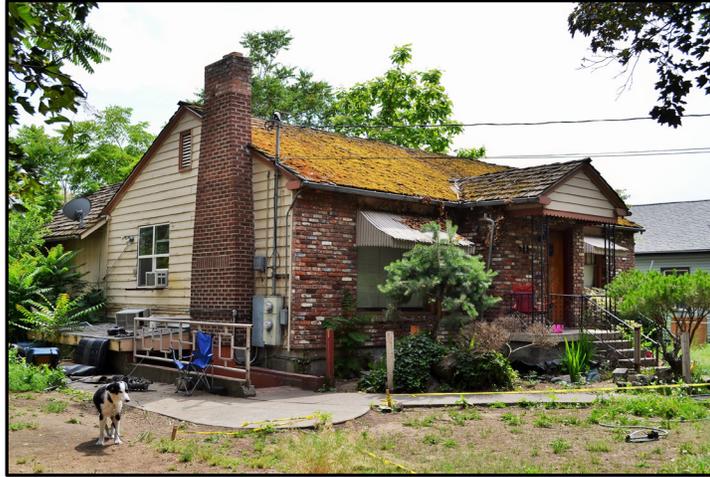
A number of Minimal Traditional houses occur in the Survey Area (Figure 16). Most of these homes are simple vernacular expressions of the style, rather than classic examples. The Minimal Traditional architectural style is a small economical house type, nearly devoid of stylistic ornament, developed in response to the Great Depression and built in large numbers from about 1935 to 1950. Typical Minimal Traditional features include low to moderately pitched roofs, close eaves and rake, large chimneys, and usually one or more front-facing gables.

Figure 16. Minimal Traditional style: House at 211 W. Chestnut St. (Project Number 10), east and north (front) sides.

Patton House, 211 W. Chestnut Street (Project Number 10): This small, rectangular wood frame house is an example of the Minimal Traditional architectural style, identified by the one-story side-gabled form, small front-facing gable, low-pitched roof, close rake, slightly overhanging boxed eaves with small cornice returns, and large chimney. The building rests on a concrete block foundation and is clad with wide lapped boards and, on the main (north) façade, distressed brick in a running bond pattern. Roofing is wood shingles. A small enclosed vestibule with a front-gabled roof is centered on the building's main façade, with the front door, an original wood slab with a metal grille peephole, off-center to the west on its face. A forward extension of the vestibule roof, supported on faux wrought iron posts, forms a shallow canopy over the front door, and faux wrought iron railings encircle the poured concrete porch deck. Two

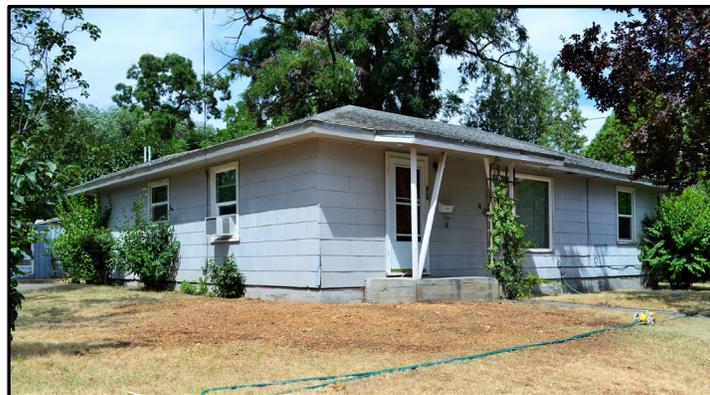
A number of Ranch style houses occur in the southern Survey Area (Figure 17). Although most are classic illustrations of the tradition, some are unusual or altered examples, identified only by certain typical features. The Ranch house, with its low horizontal profile, widely overhanging eaves, large chimneys, picture windows, and integral garage, was popular from about 1935 to 1975. The style originated in California in the 1930s, drawn from Spanish Colonial, Prairie, and Craftsman traditions, and large windows, open interior spaces, and backyard patios were employed to consciously blur the distinction between indoors and out.

Figure 17. Ranch style: House at 140 W. Morton St. (Project Number 147), west and south (front) sides.
